# **Candlewood Lake Brookfield Study Area Wastewater Management Plan**

## **Task 2 Report – Needs Analysis & Definitions**

**Prepared for:  
Brookfield Water Pollution Control Authority**

**April 3, 2020**

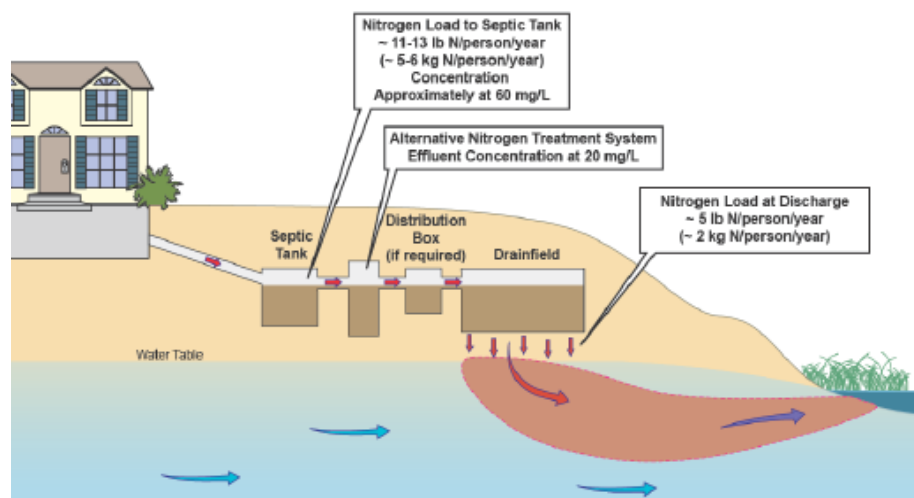
**Figure 2-1 Septic Effluent Travel to Groundwater**

For Candlewood Lake quality impacts, phosphorus is the primary concern as it is considered to be the controlling nutrient for Lake's quality. Nitrate nitrogen, which for practical purposes all wastewater nitrogen forms get converted to, is a primary concern for protection of drinking water sources due to the public health limit of 10 parts per million (ppm), which is equivalent to milligrams per liter (mg/L). However it is noted that the US EPA issued an advisory in 2015 <https://www.epa.gov/sites/production/files/documents/nandpfactsheet.pdf> that phosphorus and nitrogen should both be considered to protect lake water quality. Other constituents of concern are perfluorooctanoic acid (PFOA) and perfluorooctane sulfonate (PFOS) which can cause adverse health effects and are sometimes referred to as forever chemicals as from a practical perspective, they do not degrade. As of January 2020, the CT drinking water standards for the total of PFOA + PFOS is 70 parts per trillion (ppt). Figure 2-1, from US EPA ([https://federalleadership.chesapeakebay.net/130627\\_ches\\_bay\\_tech\\_assist\\_manual.pdf](https://federalleadership.chesapeakebay.net/130627_ches_bay_tech_assist_manual.pdf)), illustrates how septic water travels to groundwater and then to surface water.

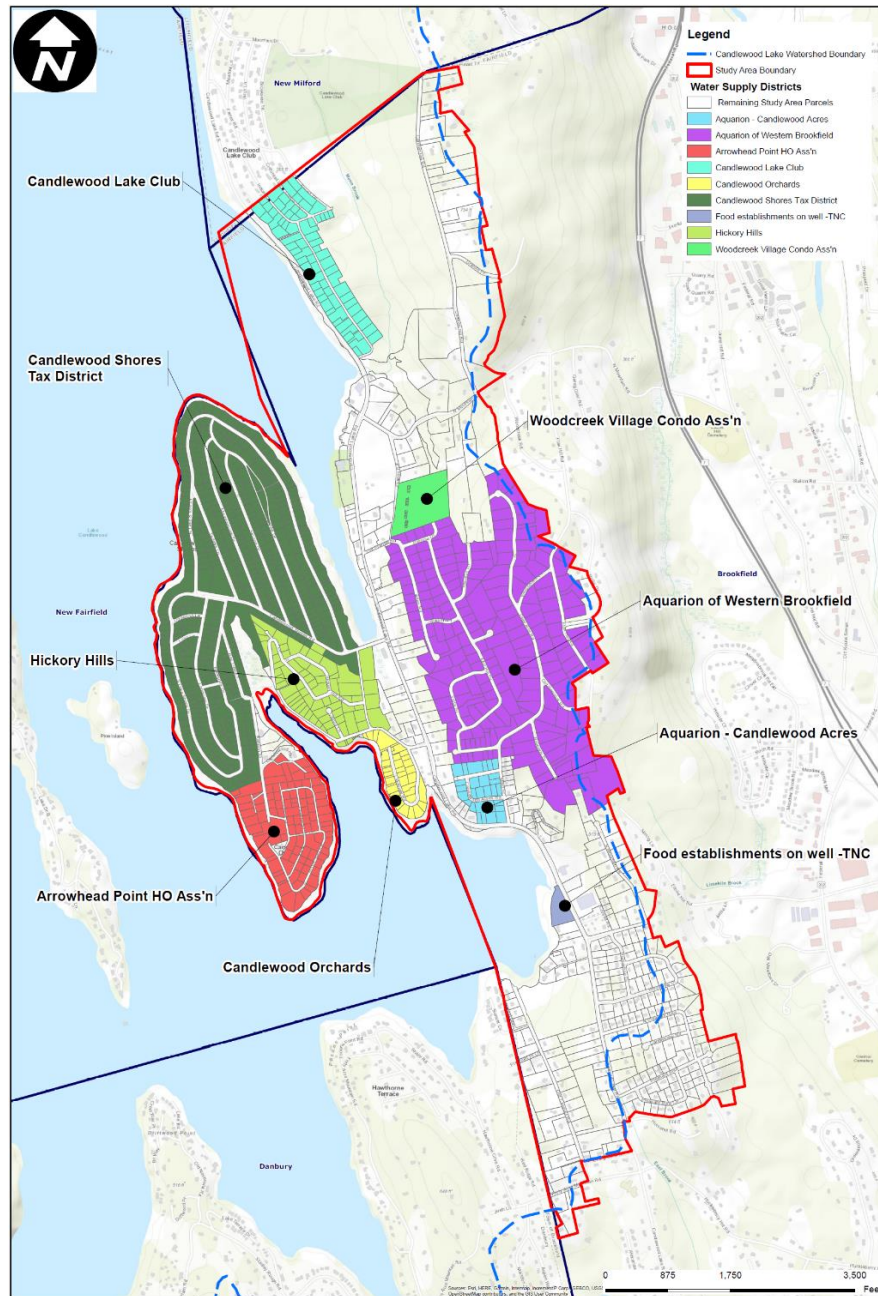
**Figure 2-3 Study Area Water Supply Districts**

Drinking water supply wells are located within the districts as shown on Figure 2-3.

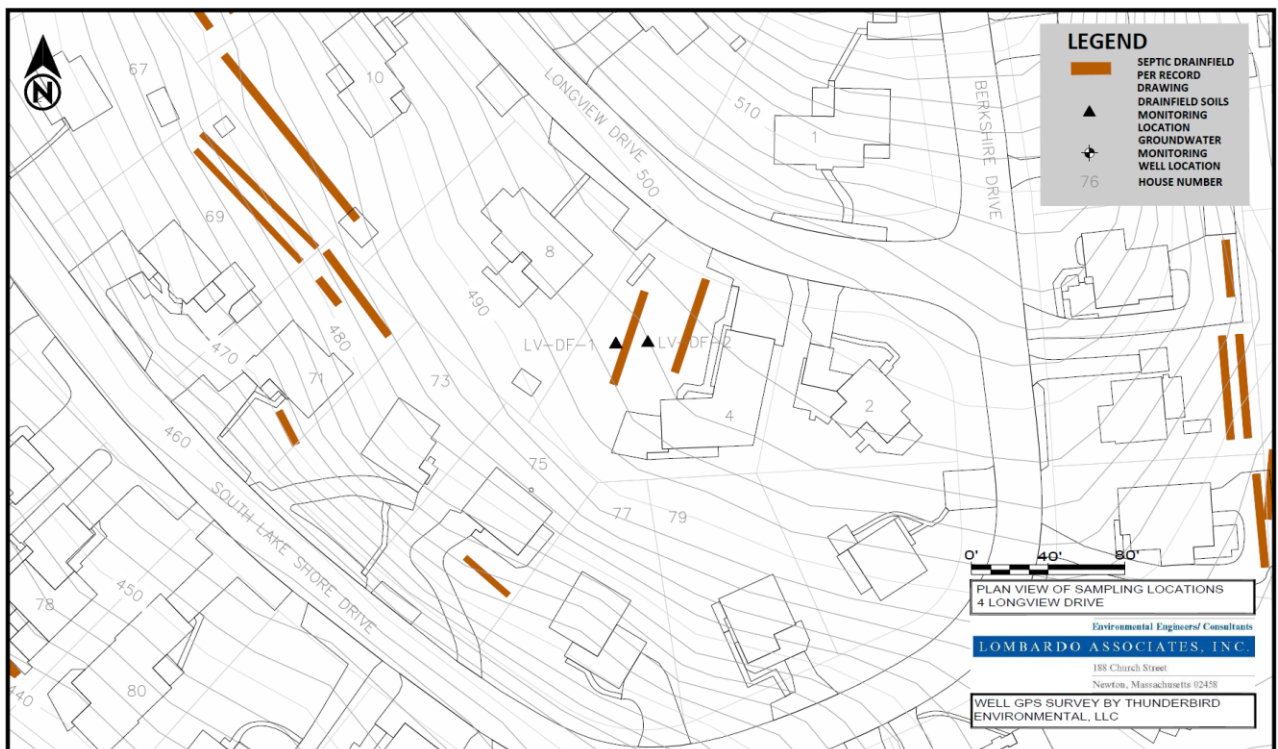
**Figure 2-5 Site Plan – 4 Longview**

Figures 2-4 through 2-6 are site plans of the three sites with septic system and soils/groundwater sampling locations indicated, respectively. Figures 2-7 and 2-8 illustrate section views of sampling locations for the 76 South Lake Shore Drive and 74 North Lake Shore Drive sites. As groundwater was not located (due to its excessive depth), no groundwater sampling was performed at 4 Longview Drive.

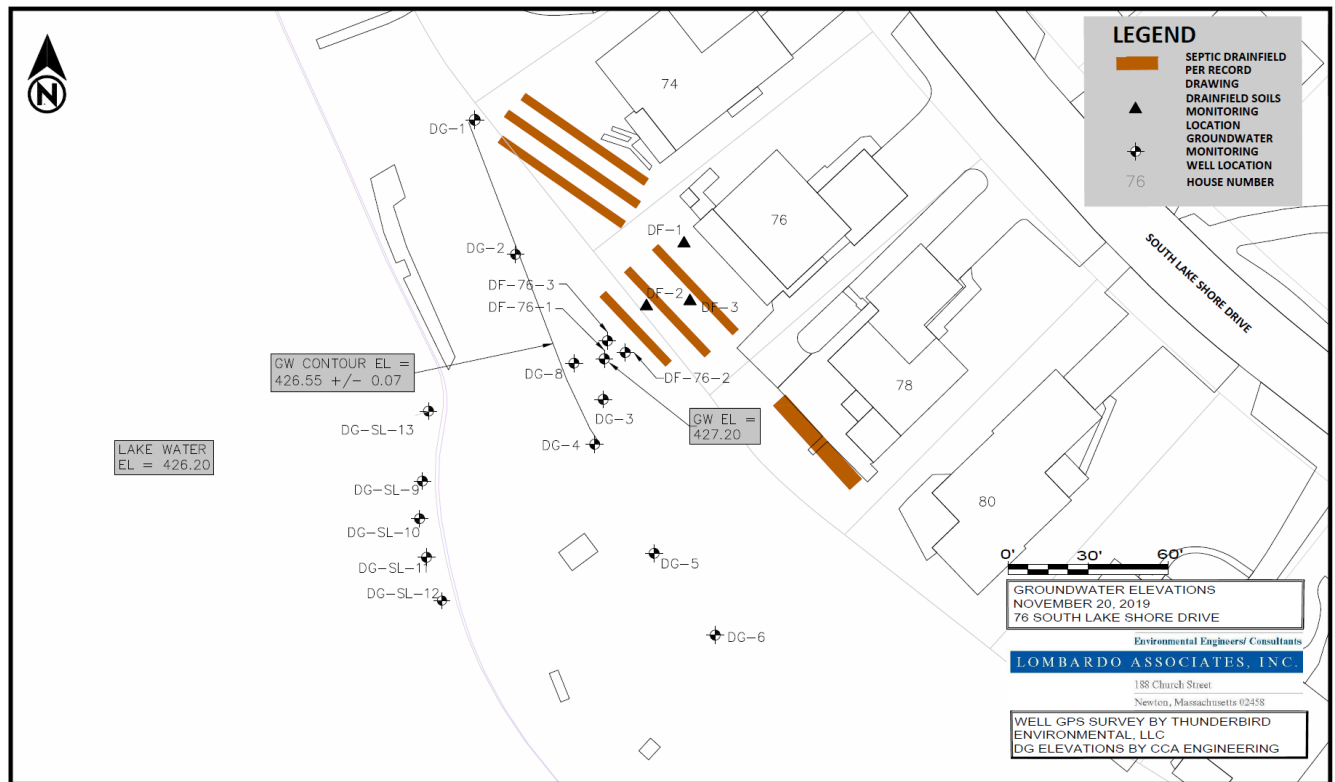
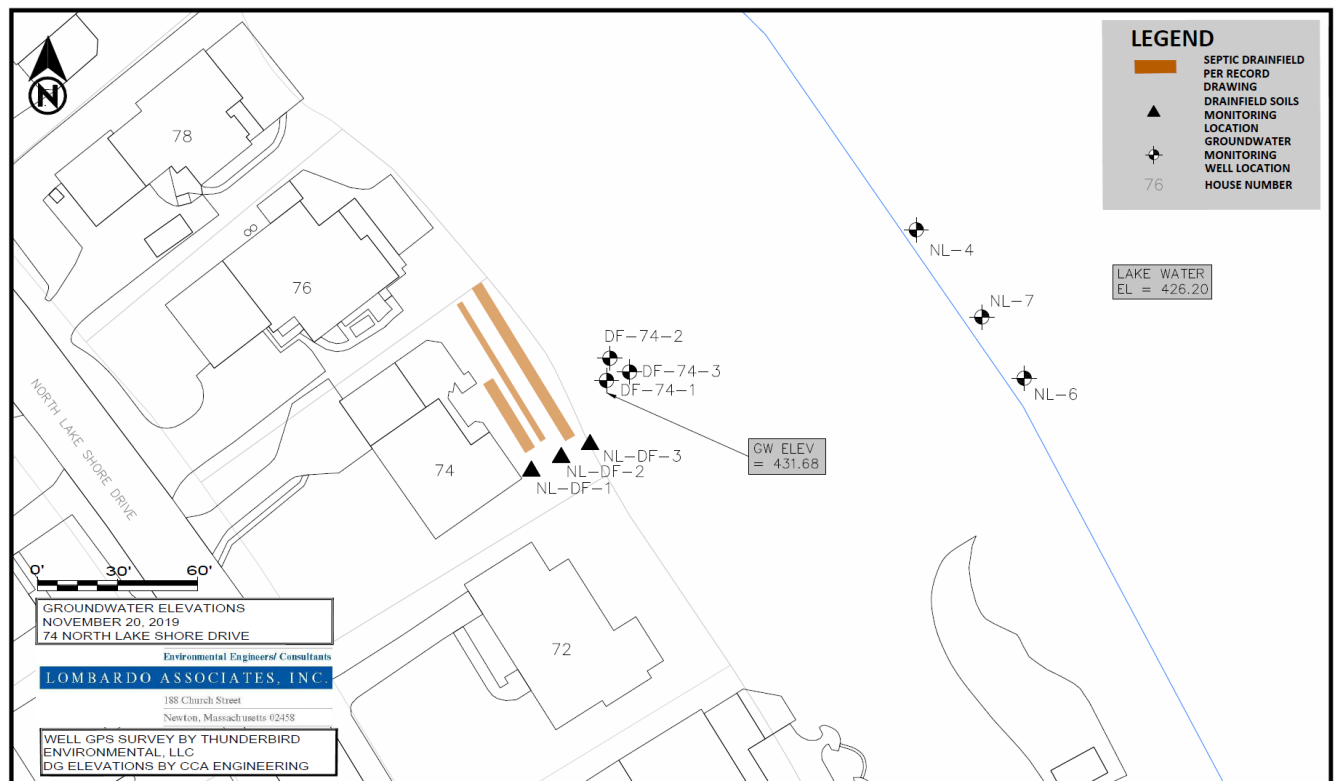
**Figure 2-10 Groundwater Contour Maps – 76 SLSD & 74 NLSD – Nov. 20, 2019**

Figure 2-10 presents groundwater contour maps for 76 South Lake Shore Drive and 74 North Lake Shore Drive sites on November 20, 2019.

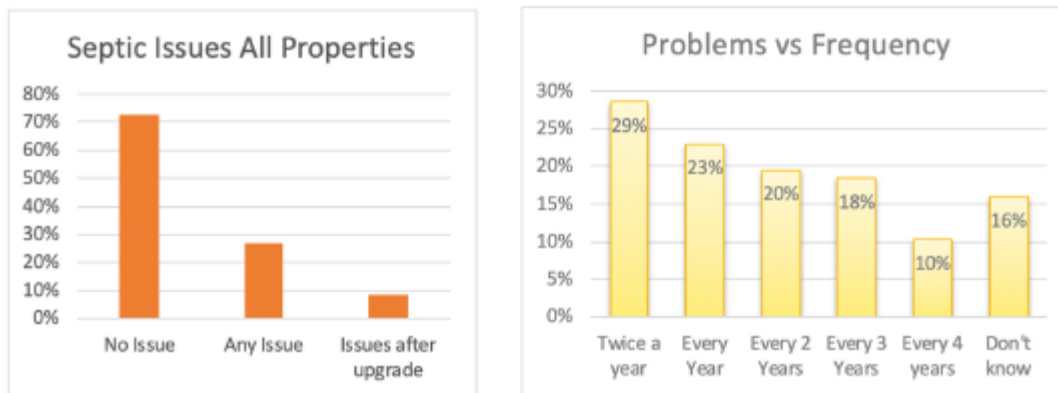
Owners were asked if there were any issues with their system specifically with a history of slow drains, backups, smell, wetness, sewage on the surface or in a ditch and if the issues still exist. Over one-quarter, 27%, report one or more of these problems. This is a relatively high incidence of septic system issues for any jurisdiction.

Further, of those reporting septic system service due to a problem, one in three (33%) of those report an issue persists, that is 8% of the total septic system count.

It was interesting to correlate those reporting issues with the frequency of pumping. It indicates those that pump more frequently do so because it is needed.

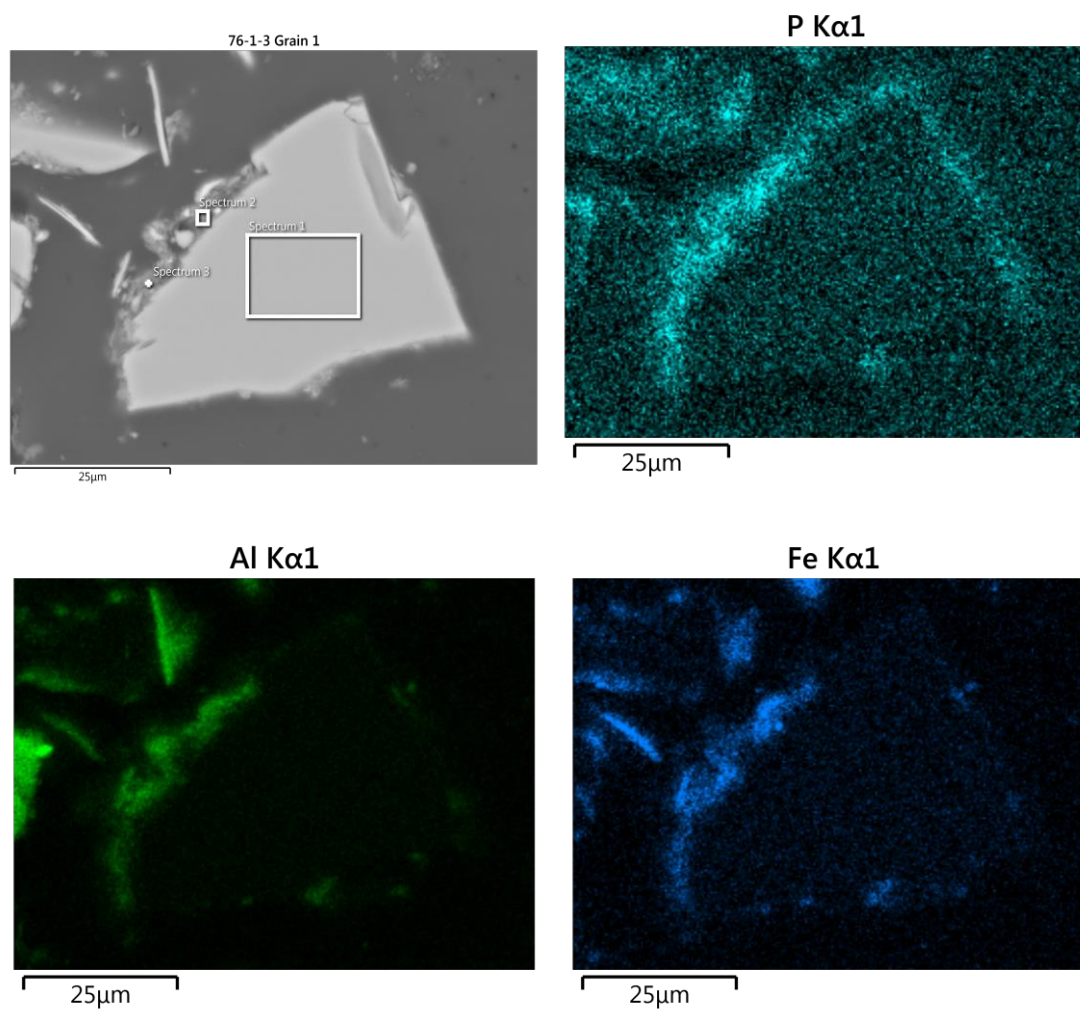
Fig. 5. Scanning electron microscope image and Xray elemental analysis of drainfield sand grain from the 76 site, showing secondary mineral coating on a quartz grain (core 76-1, 3' depth). Coating composition (Spot 2) is 2.4 % P, 8.4 % Al, 8.6 % Fe and 1.2 % Ca. For full compositional analysis see Appendix A.

Distinct secondary mineral coatings were readily observed in all of the sediment samples submitted for scanning electron microscope analysis. Coatings were typically 5-20  $\mu\text{m}$  in thickness and occurred on a variety of mineral grains including quartz, feldspar and ferro magnesium minerals (Figs. 5-7). The coatings almost always contained phosphorus (0.5- 2.5 wt %) and always had Al and Fe as the dominant cations (5-20 wt %), whereas Ca was usually only a minor component ( $< 3 \text{ wt } \%$ , Figs. 5-7, Appendix A). Similar secondary mineral coatings have been observed in the drainfield sediments at other septic system sites, particularly at sites where the sediments are non calcareous (Robertson et al., 2019). These coatings reflect mineral precipitation reactions that likely play a dominant role in limiting phosphorus concentrations occurring in the related groundwater plumes. The precipitation reactions result in zones of P enrichment within the drainfield sediments (Fig. 4) and these zones are almost always focused within 2-4' below the infiltration pipes, even in drainfields that vary widely in age (Robertson et al., 2019). This indicates that mineral precipitation reactions occur rapidly after the effluent enters the subsurface and that they are sustainable over the long term. In one previous study where the drainfield sediments were sampled in greater detail, it was determined

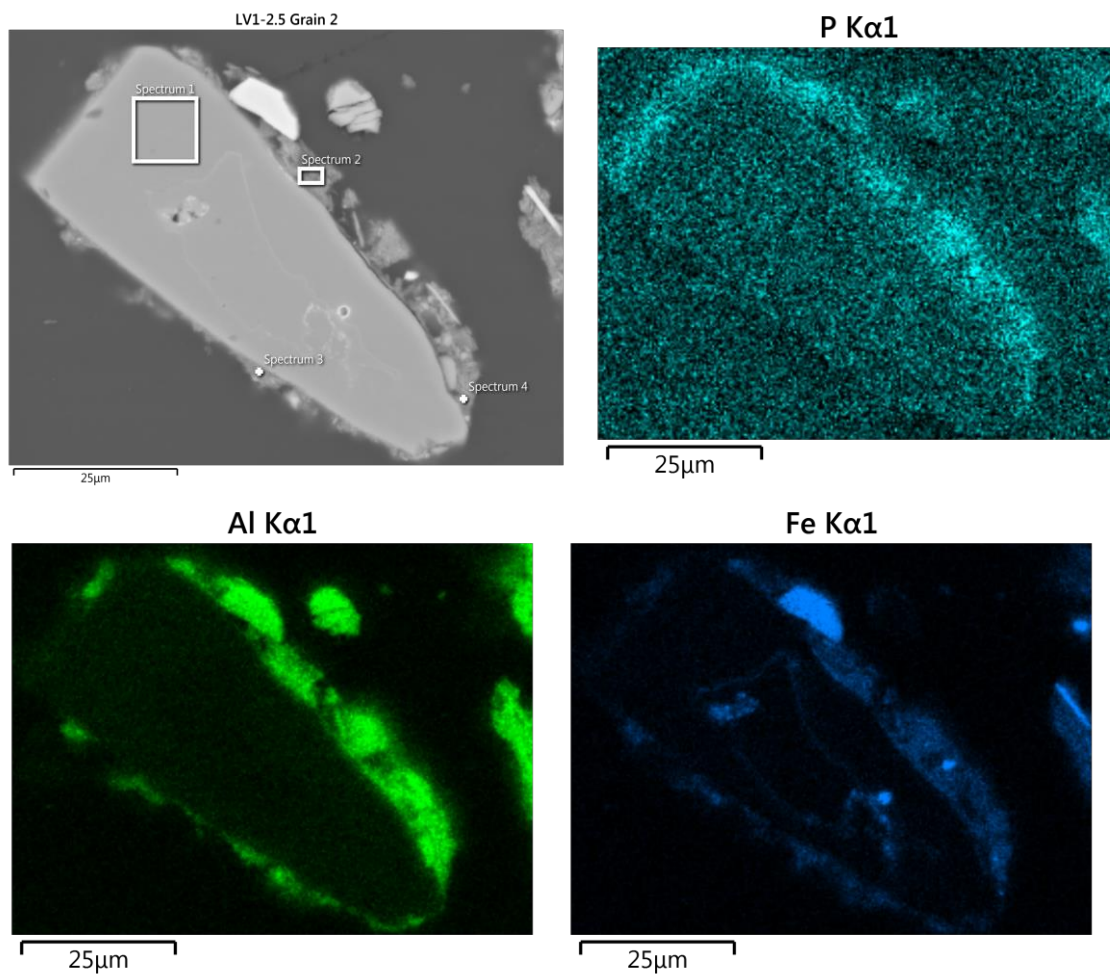
Fig. 6. Scanning electron microscope image and Xray elemental analysis of drainfield sand grain from the LV site, showing secondary mineral coating on a quartz grain (core LV1, 2.5' depth. Coating composition (Spot 2) is 0.7 % P, 13.6 % Al, 10.2 % Fe and 0.9 % Ca. For full compositional analysis see Appendix A.

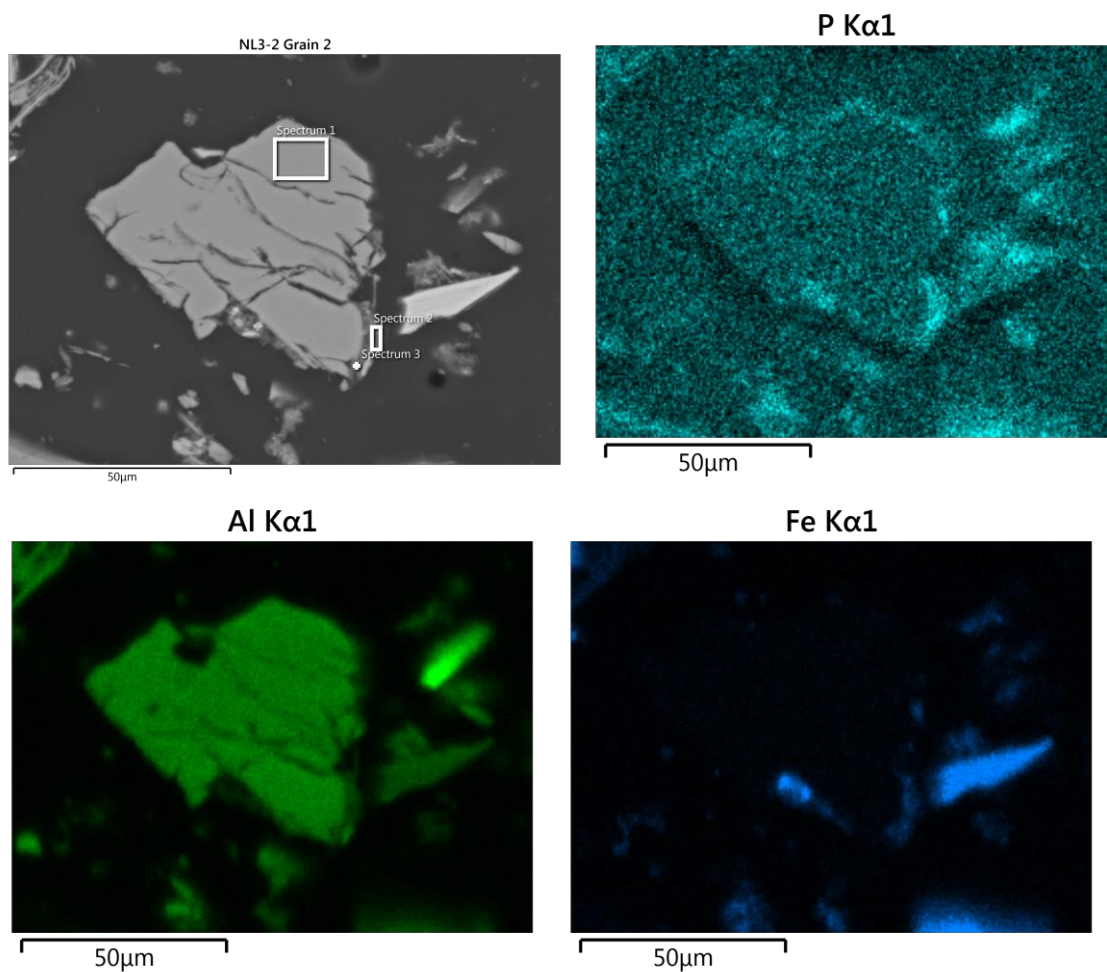
Fig. 7. Scanning electron microscope image and Xray elemental analysis of drainfield sand grain from the NL site, showing secondary mineral coating on a plagioclase feldspar grain (core NL3- 2' depth). Coating composition (Spot 2) is 1.2 % P, 9.0 % Al, 8.1 % Fe and 1.1 % Ca. For full compositional analysis see Appendix A.

The drainfield sediments at all three sites are non calcareous ( $\text{Ca} < 2 \text{ wt } \%$ ) and have typical concentrations of acid extractable Al and Fe (1-3%, Table 2), presumably reflecting the presence of oxyhydroxide mineral phases in the drainfield sediments. At all three sites, variable amounts of P enrichment was observed in the drainfield coreholes. Desorbable P values of up to 139 mg/kg were measured within distinct P enrichment zones (e.g. 76-1, 3.0 ft depth) compared to background values of about 5 mg/kg (Table 2, Fig. 4). Acid extractable P was enriched in the same zones, but to a much greater extent. For example, in sample 76-1, 3.0 ft depth, acid extractable P was measured at 2320 mg/kg, compared to background values of  $\sim 800 \text{ mg/kg}$  (Table 2). This indicated P enrichment of  $\sim 1500 \text{ mg/kg}$ , which is an order of magnitude higher than the desorbable P amount of 139 mg/kg. This demonstrates that most of the P retained in the P enrichment zones is not readily desorbable, but rather, suggests the presence of less soluble secondary P-mineral phases (see below). Background values of acid extractable P ( $\sim 800 \text{ mg/kg}$ ) are presumed to reflect the presence of trace amounts of primary apatite in the sediment. A prominent apatite grain was, in fact, captured in one of the SEM/EDX analyses (NL2, 4 ft depth, Appendix A).
