WASTEWATER FACILITES PLAN REPORT

Brookfield Water Pollution Control Authority

August 2020

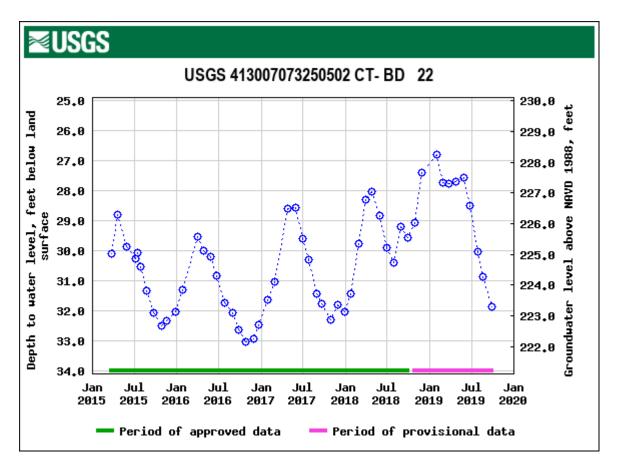
Figure 3-3: Depth to Groundwater at a USGS Water Table Well Located at the Brookfield/New Milford Line on Route 202 Showing High Seasonal Groundwater Levels

seasonally high (see **Figure 3-3**). **Table 3-7** presents a flow component analysis during this period.

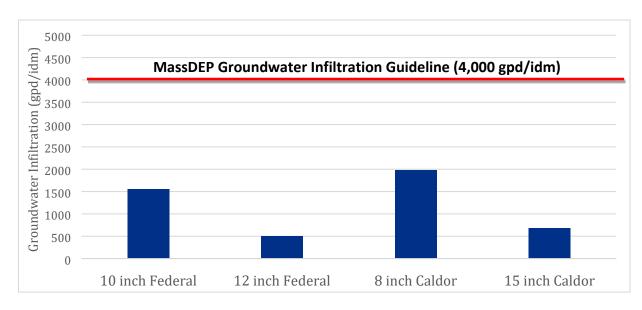
Figure 3-4: Maximum Daily Groundwater Infiltration Rate Normalized by Inch-Diameter-Mile in Spring 2018 for the Four Brookfield Gravity Meters

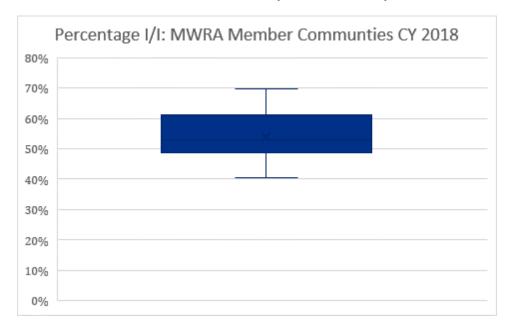
Figure 3-5: Percentage of Average Daily Flow that is Inflow or Infiltration Across the 43 MWRA Member Communities in Calendar Year 2018

percentage I/I (as a percentage of the total flow) was 54 percent, with a minimum of 41 percent and a maximum of 70 percent. A box-and-whisker plot showing the overall range of I/I expressed as a percentage of overall average daily flow across the MWRA member communities is shown in **Figure 3-5**. Compared with these figures, the estimated proportion of I/I in the Brookfield system is average to significantly below average, supporting the findings in this report that the overall I/I contribution in the Brookfield collection system is relatively low.

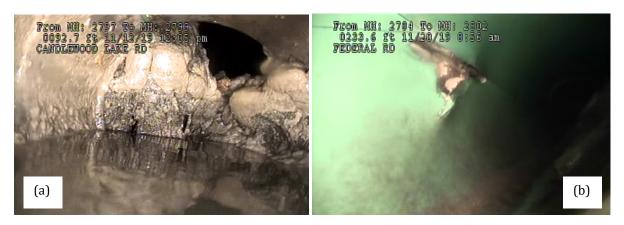
Figure 3-7 (a) Grease at downstream end of 2797-2799. (b) Intruding Object through Pipe Wall of 2784-2802 at 234 LF from upstream manhole.

The majority of the inspected pipe sections are in good condition and are recommended for regular cleaning due to grease present as well as sags, which could allow for debris to settle. Pipe segment 2770-2771 on Federal Road requires debris removal due to an object impeding flow towards the downstream end of the pipe segment. The pipe just upstream of Caldor Pump Station on Candlewood Lake Road, segment 2797-2799, requires cleaning at the downstream end due to deposits and grease at the connection to the Pump Station, shown in **Figure 3-7a**. Segment 2784-2802, also on Federal Road, near the intersection with Gray's Bridge Road, is recommended for a point repair. The defect is an object protruding through the wall of the pipe, as seen in **Figure 3-7b**.

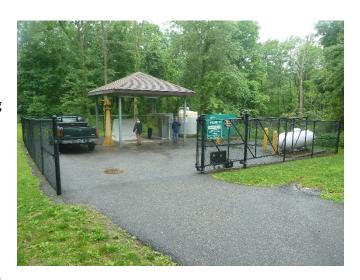
The Cedarbrook Pumping Station is a submersible, centrifugal pump style pumping Station located at approximately 12 Cedarbrook Road. The station was constructed in 2008. The site consists of a concrete wet well chamber, above grade valve enclosure, outdoor main control panel, outdoor emergency generator, above grade fuel tank, and bioxide storage tank and feed system. The wet well, valve enclosure, and control panel are covered by a roof structure.

The site is located off the road is surrounded by a chain link fence with vehicle gate.

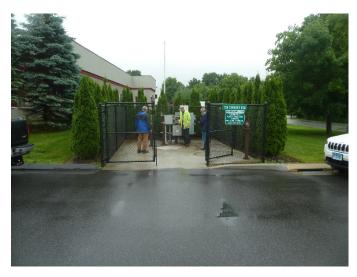
The Commerce Drive Pumping Station is a submersible, centrifugal pump style pumping Station located near 101 Commerce Road. The station was constructed in 2014. The site consists of a concrete wet well chamber, concrete dry well valve vault, and outdoor main control panel with portable generator connection. The site is located off the road and is surrounded by a chain link fence with vehicle gate.

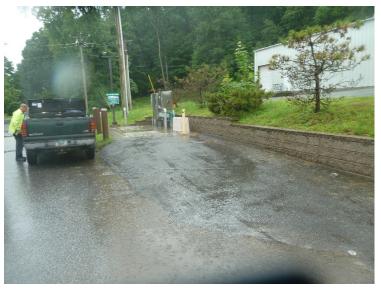
The Del Mar Pumping Station is a submersible, centrifugal pump style pumping Station located at approximately 56 Del Mar Drive. The station was constructed in 2012. The site consists of a concrete wet well chamber, concrete valve vault, and outdoor main control panel with portable generator connection. The site is located off the road and does not have any fencing. The station is at the end of a dead-end road.

The station conveyance system is contained within two precast concrete below grade vaults: a wet well with two submersible pumps and station level controls; and a valve vault containing the individual pump check and isolation valves, the outgoing force main pipe, and bypass connection piping and valve.

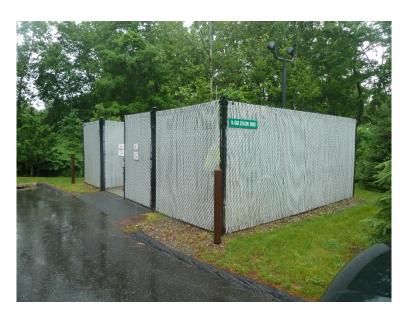
The High Meadow Pumping Station is a submersible, centrifugal pump style pumping Station located at the end of Eastview Drive in the High Meadow Condominium Complex. The station was constructed in 2014. The site consists of a concrete wet well chamber, concrete valve vault, outdoor main control panel, and outdoor emergency generator. The site is located off the road and is surrounded by a chain link fence with manual gate.

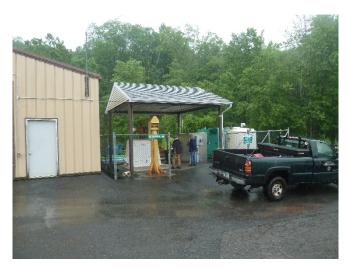
The High School Pumping Station is a submersible, centrifugal pump style pumping Station located at next to the high school at 45 Long Meadow Hill Road. The station was constructed in 2005. The site consists of a concrete wet well chamber, above grade valve enclosure, outdoor main control panel, outdoor emergency generator, above grade fuel tank, and bioxide storage tank and feed system. The wet well, valve enclosure, and control panel are covered by a roof structure. The site is located off the road is surrounded by a chain link fence with vehicle gate.

The station conveyance system is contained within the precast concrete wet well and above grade valve enclosure. The wet well contains the two submersible pumps, station level controls, and incoming 8" sewer. The valve enclosure provides protection for the isolation valves on pump discharges and force mains, and pump disconnects. A bypass connection is located on the exterior of the enclosure.

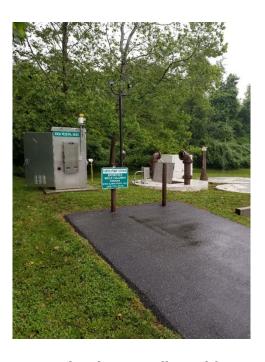
The station conveyance system is contained within three precast concrete below grade vaults: an incoming sewer vault; wet well with two submersible pumps, trash basket, and station level controls; and a valve vault containing the individual pump check and isolation valves, the two outgoing force main pipes, flow meter, and bypass connection piping and valve.

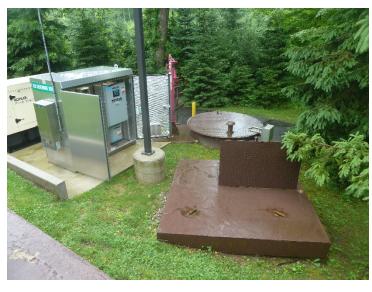
The Railroad Pumping Station is a submersible, centrifugal pump style pumping station located at approximately 35A Silvermine Road. The station was constructed in 1996 and last upgraded in 2015. The site consists of a concrete wet well chamber, concrete valve vault, concrete meter vault and outdoor main control panel with portable generator connection. The site is located off the road but does not have fencing.

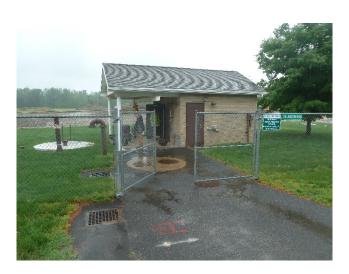
The Route 133 Pumping Station is a submersible, centrifugal pump style pumping Station located at approximately 120 Junction Road (Route 133). The station was last upgraded in 2006. The site consists of a concrete wet well chamber, concrete dry well valve vault and one-story control building with indoor emergency generator. The control building roof extends over the wet well access hatch. The site is located off the road and is surrounded by a chain link fence with vehicle gate.

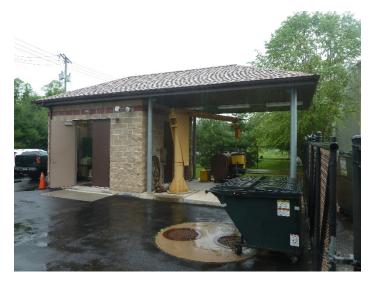
The Sand Cut Pumping Station is a submersible, centrifugal pump style pumping station located at approximately 2 Sand Cut Road. The station was constructed in 2008. The site consists of a concrete wet well chamber, concrete dry well valve vault and one-story control building with indoor emergency generator. The control building roof extends over the wet well access hatch and jib crane. The site is located off the road and is surrounded by a chain link fence with vehicle gate.

The station conveyance system is contained within three precast concrete below grade vaults: a grinder vault with incoming 8" sewer, one wastewater grinder, bypass channel, and channel gates; wet well with two submersible pumps and station level controls; and a drywell containing the individual pump check and isolation valves, the single outgoing force main pipe, flow meter, and bypass connection piping and valve.

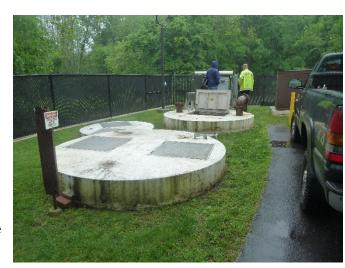
The station conveyance system is contained within three precast concrete below grade vaults: an incoming sewer vault; wet well with two submersible pumps, trash

basket, and station level controls; and a drywell containing the individual pump check and isolation valves, the two outgoing force main pipes, flow meter, and bypass connection piping and valve.

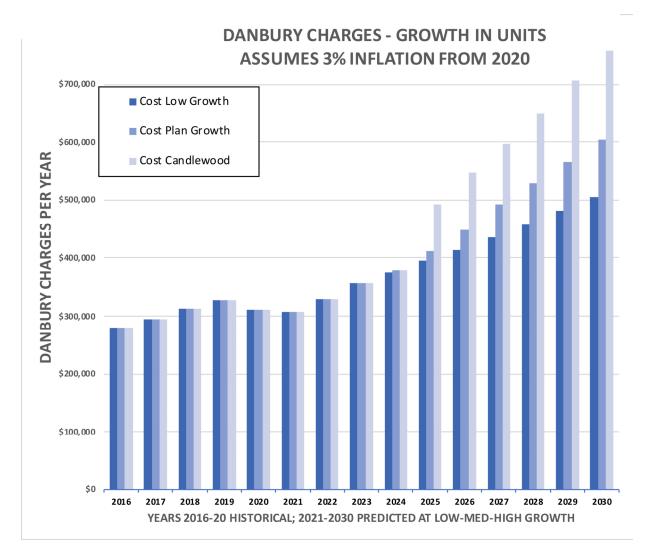
Figure 6-1 Danbury Toll Charges for Low, Medium and High Growth.

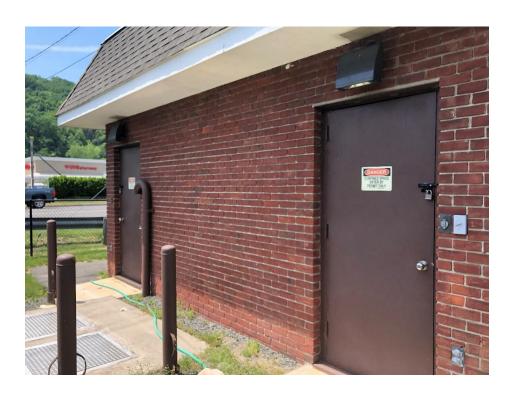
FIGURE A.4.2(f) Abovegrade Equipment Housing or Vault not Physically Separated from Wet Well or Basin; Illustration of Table 4.2.2, Row 19.

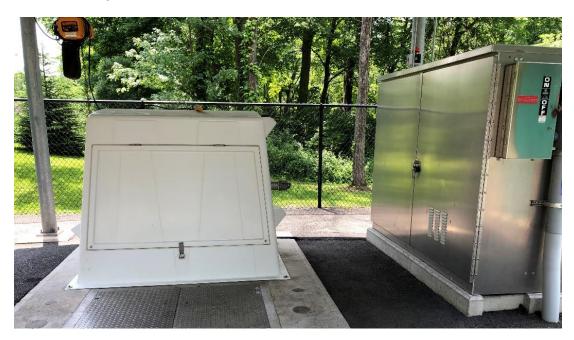
• NFPA 820 required a 5-foot separation between any source of gas and all electrical equipment. The exhaust fan in the fiberglass enclosure and wet well vent are within 5-feet of the electrical equipment enclosure. To address these items, we recommend the existing exhaust fan be replaced with a continuously running supply fan, the air intake damper to be changed to an exhaust air damper and re-route the vent pipe to the opposite side of the fiberglass enclosure.

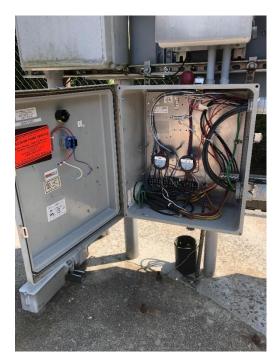
Langan/Keystone Comments: This is a pump station that was recently taken over by the WPCA and many of these conditions existed when the WPCA took over the operation and maintenance of this system. The wet well hatch as an 18-inch high and 3'-0" wide class 1, division 2 area classification around it. There is one (1) piece of equipment mounted on the rack that measures 15-inches from the ground. We recommend this enclosure be replaced with a smaller box which will then bring the bottom of the equipment to 18-inch from the ground. This equipment box serves as a splice box to the pump control panel and can easily be modified as recommended and the pump run time meter can be relocated into the pump control panel if necessary.

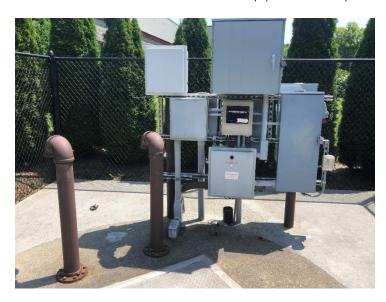
2. Draft Facilities Plan Deficiency comment (page 4-13): PVC conduit is located in the explosive area

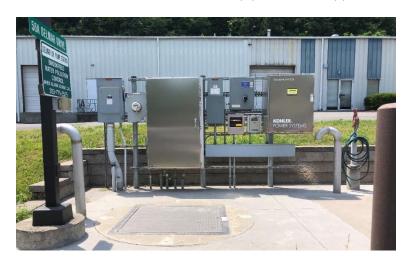
• The valve pit vent pipe adjacent to the Kohler Automatic Transfer Switch is located within a controlled area. To address this issue, this vent pipe can be capped.

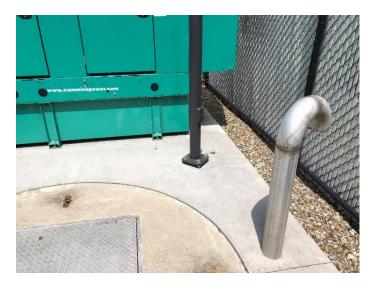
• The vent pipe is located 4'-10" from the generator. It is recommended to rotate the vent pipe to face the opposite direction of the generator to provide a 5'-0" clearance.

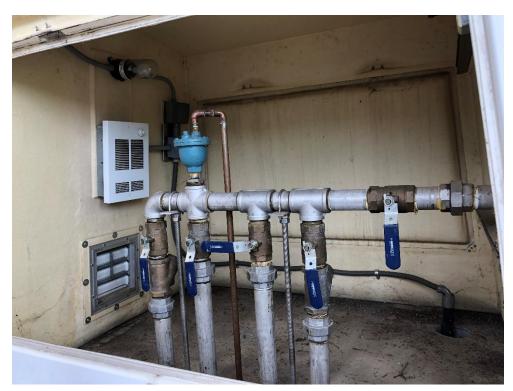
- The gas tight seal off fittings should be installed on all electrical and instrument conduits connected to the wet-well.
- The enclosure is classified as class 1, division 2. Instead of replacing the components with NEMA 7, we recommend that the existing fan to be re-wired to run continuously at a 6- air change per hour. This will de-rate the enclosure to unclassified. The continuously running fan should be monitored through the Mission Control system.

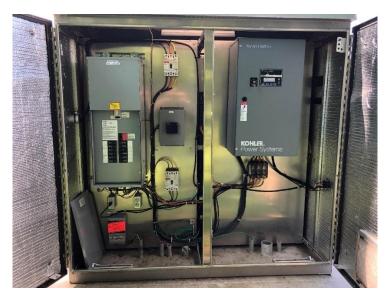
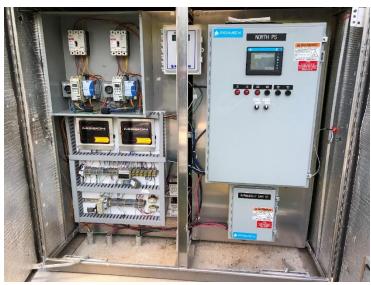
1. Draft Facilities Plan Deficiency comment (page 4-21): The wiring enclosed within the pedestal cabinet is not NEC code compliant, all the wiring and cable terminals are installed exposed with no physical protection for the cables.

Langan/Keystone Comments: We have a different interpretation of this code requirement. It is our opinion that the panel is NEC compliant in accordance with Article 409 – Industrial Control Panels. Our interpretation is that this is an industrial control panel constructed in the field and therefore compliant.

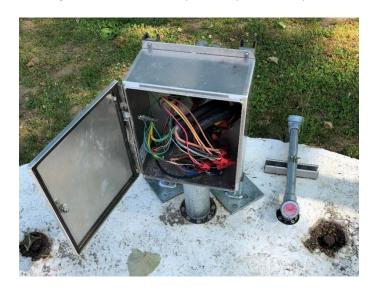
2. Draft Facilities Plan Deficiency comment (page 4-21): The junction box installed for the wet well is not NEC compliant for an explosive area.

Langan/Keystone Comments: The approved plans called for an explosion proof box. We recommend that the existing box be with an explosion proof box per NEC 501.15.

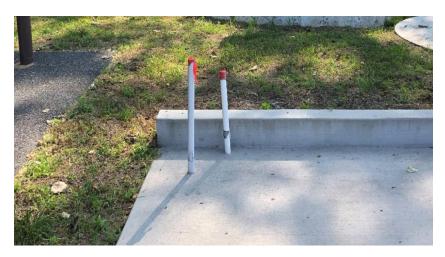
• We recommend to place a conduit cap on all open conduits per NEC 110.12(A). See picture below:

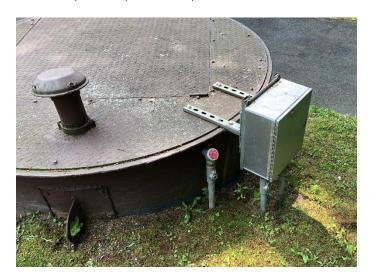
• The approved plans called for an explosion proof box. We recommend that the existing box be replaced with an explosion proof box per NEC 501.15.

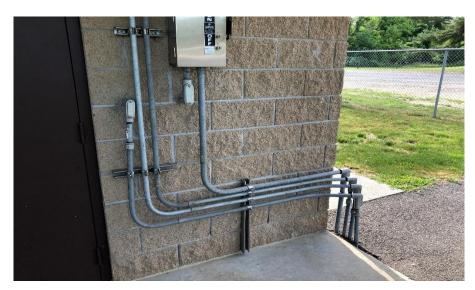
- The wet well hatch is located 2'-6" from the double doors and is required to be 3-feet. The class 1, division 2 area classification extends into the pump station building. A potential solution would be to remove the double doors. There is no longer a need for a double door since the generator will be removed as part of another project. The single door on the roadside of the station would be sufficient for equipment access. We recommend that this modification be incorporation into the future planned pump station upgrade.
- There are no conduit seals on the grinder conduits. We recommend to install conduit seals. See picture below:

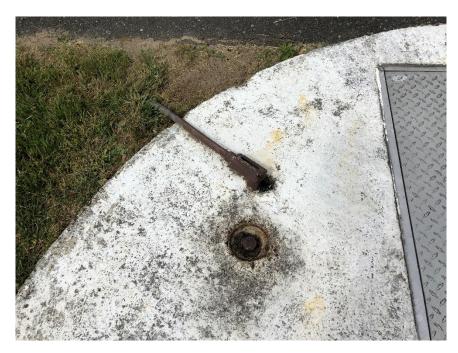
There are exposed wires with broken conduits. This is a NEC code violation per NEC 300.4. We believe these conduits/wires are abandoned and if so, conduit should be removed and the opening sealed watertight material (see photo below for reference).

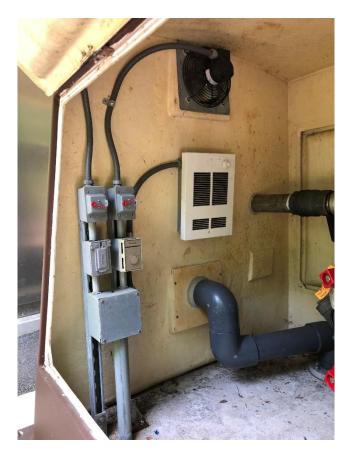
• The enclosure is classified as class 1, division 2 which would require NEMA 7 components. To address this concern, we recommend that the existing fan be re-wired to run continuously at a 6-air change per hour. This will de-rate the enclosure to unclassified. The continuously running fan should be monitored by Mission Control system.

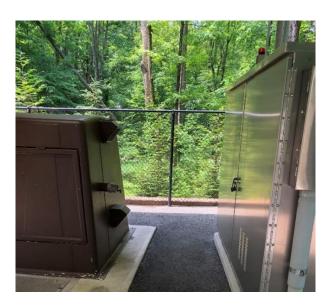
• The exhaust fan in the fiberglass enclosure and wet well vent are within 5-feet of the electrical equipment enclosure. In addition to a continuously running fan, we recommend that the exhaust fan be replaced with a supply fan, change the air intake damper to an exhaust air damper and re-route the vent pipe to the opposite side of the fiberglass enclosure.

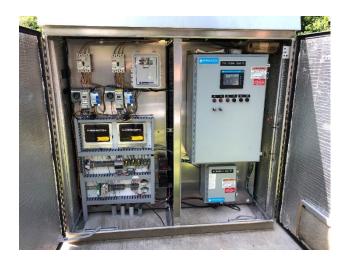
2. Draft Facilities Plan Deficiency comment (page 4-33): The junction box installed for the wet well is not NEC compliant for an explosive area.

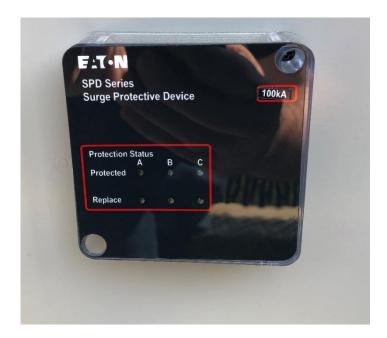
• The surge protection lights are not on. This could indicate the equipment is not operating correctly and not providing adequate protection to the pump station from power surges. We recommend that it be tested and replaced as necessary.
