Candlewood Lake Brookfield Study Area Wastewater Management Plan

Task 1 Report – Community Profile and Data Review

**Prepared for:
Brookfield Water Pollution Control Authority**

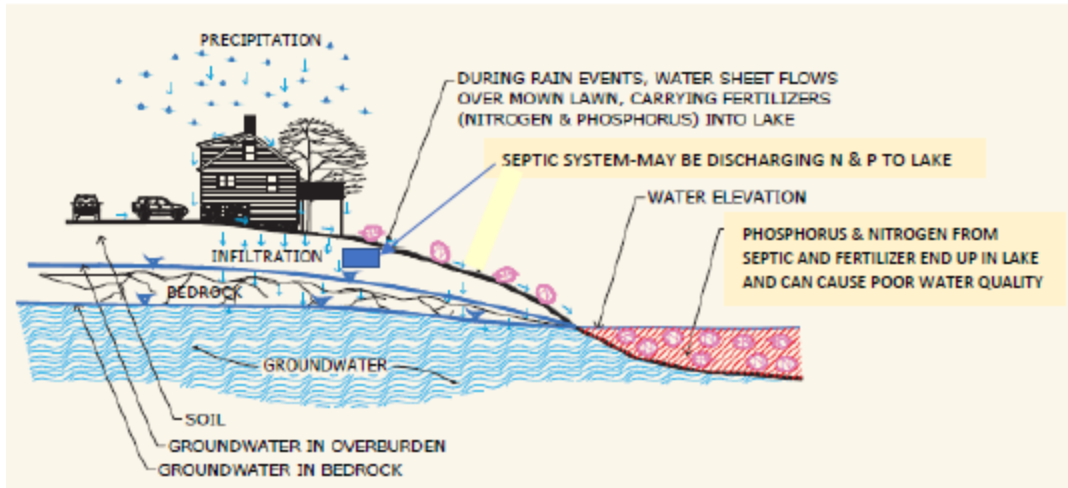
Figure 2-6 Hydrology Cross Section

While there are no known studies on the Study Area's groundwater, it is understood to exist in the overburden and bedrock as depicted by Milone & MacBroom, Inc. (2014) (used with permission) with modifications by LAI and shown on Figure 2-6. There are no known instances of perched groundwater or data that suggest that perched groundwater would exist. There are no known documents presenting area-wide depth to groundwater data for the Study Area.

Without data, it will be assumed that groundwater is slightly above (we will use 1 foot) Lake elevation and that groundwater sub-watershed divides match surface water sub-watershed divides, which are dictated by surface topography. Further discussion on surface water and groundwater sub-watersheds and flow paths is presented in Section 3.7.

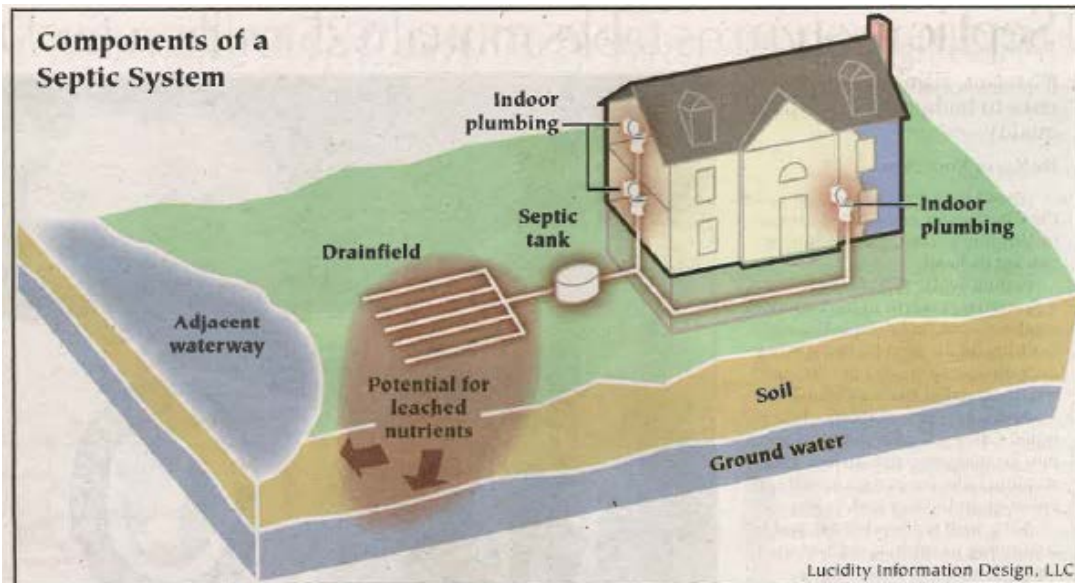
Figure 2-8 Residential OWTS Schematic

It is understood that all wastewater systems in the Study Area rely predominately upon septic tank drainfields as shown on Figure 2-8, from the [Bay Journal](#) (July-August 2019). While there may be cesspools on some properties due to their age and practices at the time, it is expected to be an insignificant number as CT DoH banned cesspools in the 1950s and Study Area site conditions are not conducive to the use of cesspools.

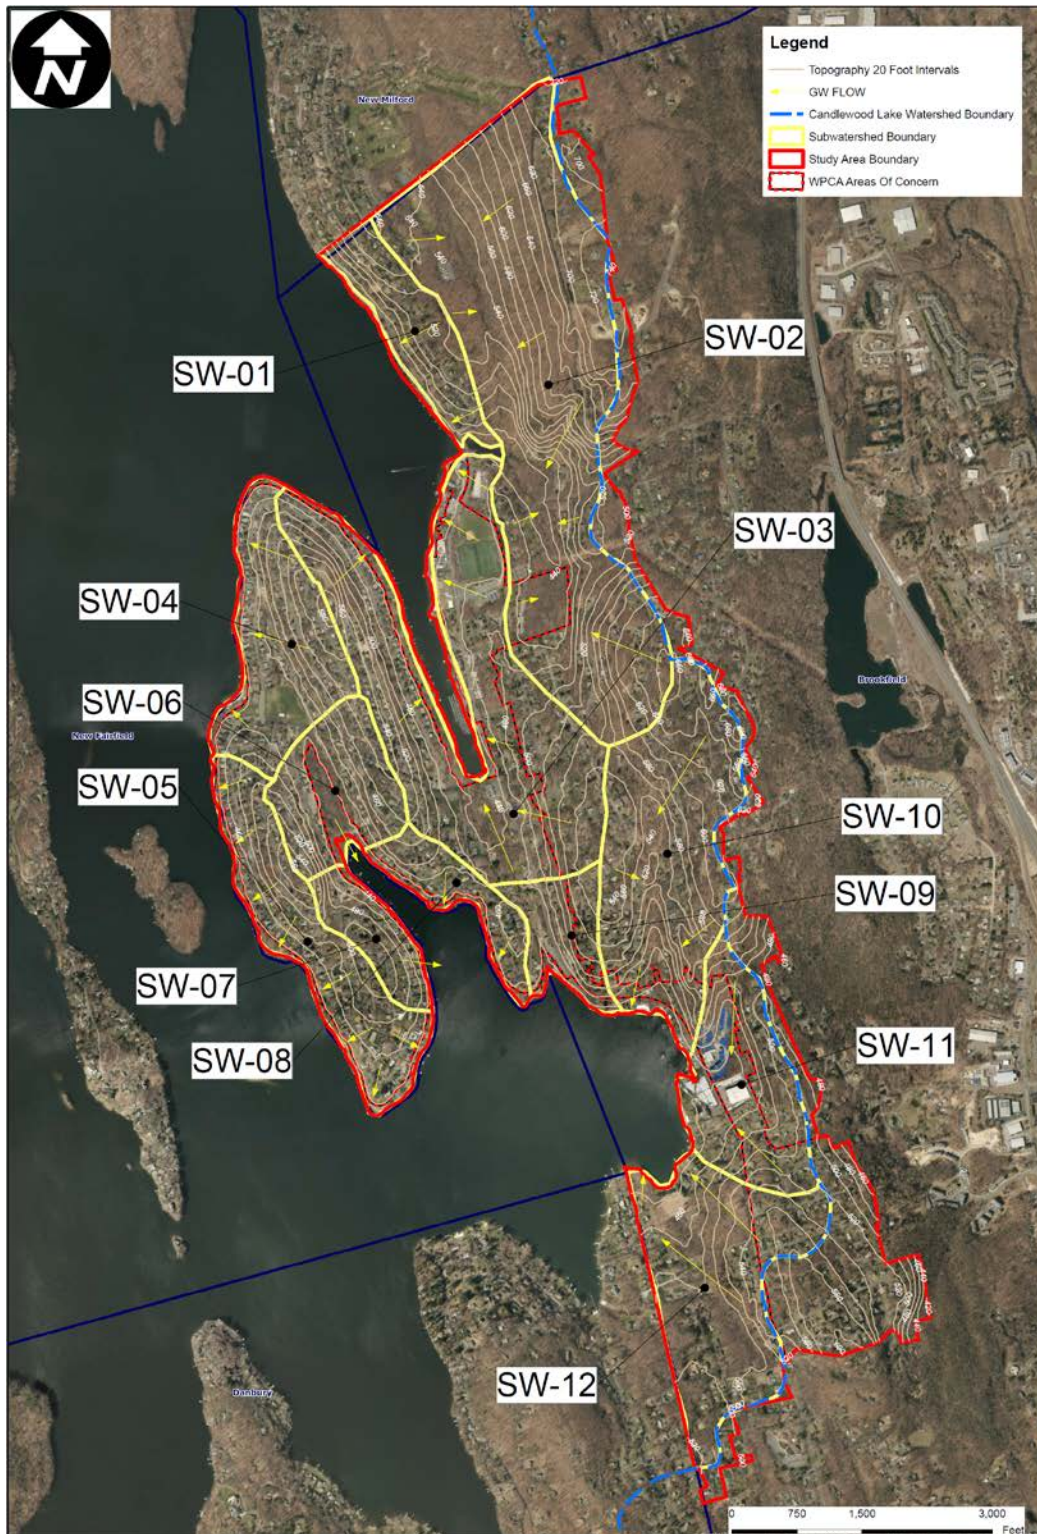
Figure 3-8 Sub-watershed Boundaries & Estimated Surface/Groundwater Flow Paths

Groundwater travel time is important to know as it indicates how long a septic plume would take from its initiation to receipt by the water body. This is important for design and evaluation of field data collection efforts. Additionally, along with the Lake's turnover time of 3.3 years (see Section 4), groundwater travel time is used to determine the length of time it would take for the Lake to reflect water quality improvements resulting from wastewater systems improvements.

For groundwater flow paths to the Lake ranging from 100 feet (for shoreline properties) to 500 feet (properties at the top of the estimated subwatershed), groundwater travel times to the Lake could be approximately 500 days (shoreline properties) to 2,500 days (top of the subwatershed). Groundwater in the bedrock would travel at a significantly lower rate.

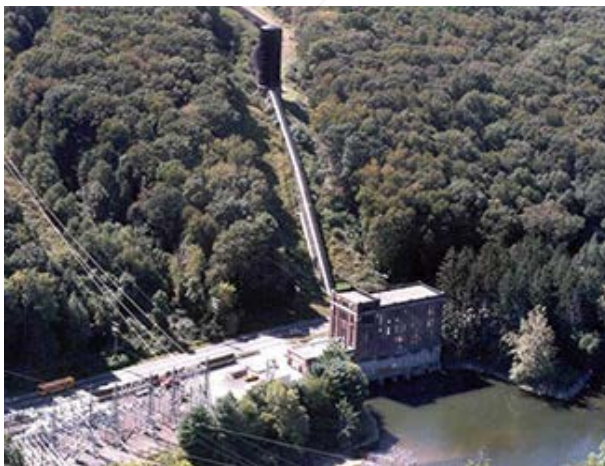
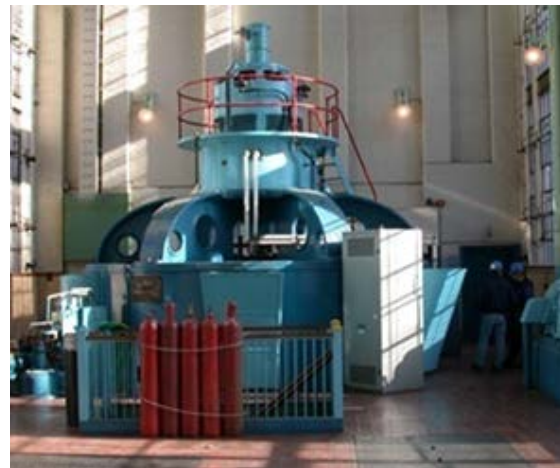
Figure 4-3 Rocky River Generating Station

The Rocky River Generating Station, Figure 4-3, is a three-unit hydroelectric station with a capacity of 29 MW using 2 GE 3.5 MW turbines and 1 GE 23 MW turbine and is operated by [First Light Power Resources](#) subject to Federal Energy Regulatory Commission (FERC) permitting requirements.

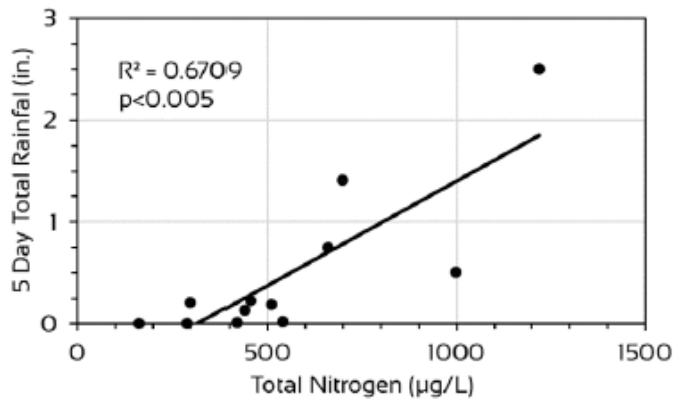
**Figure 4-7
Relationship
Between Total
Rainfall in 5 Days
Prior to Sampling
and Lake TN & TP**

Figure 4-7, from AER 2019, illustrates Relationship between Total Rainfall in 5 days Prior to Sampling and Lake Average TN and TP, which suggests potential septic influence.

Figure 19. Relationship between total rainfall in the five days prior to sampling and the lake average total nitrogen concentration at Candlewood Lake in 2017 and 2018

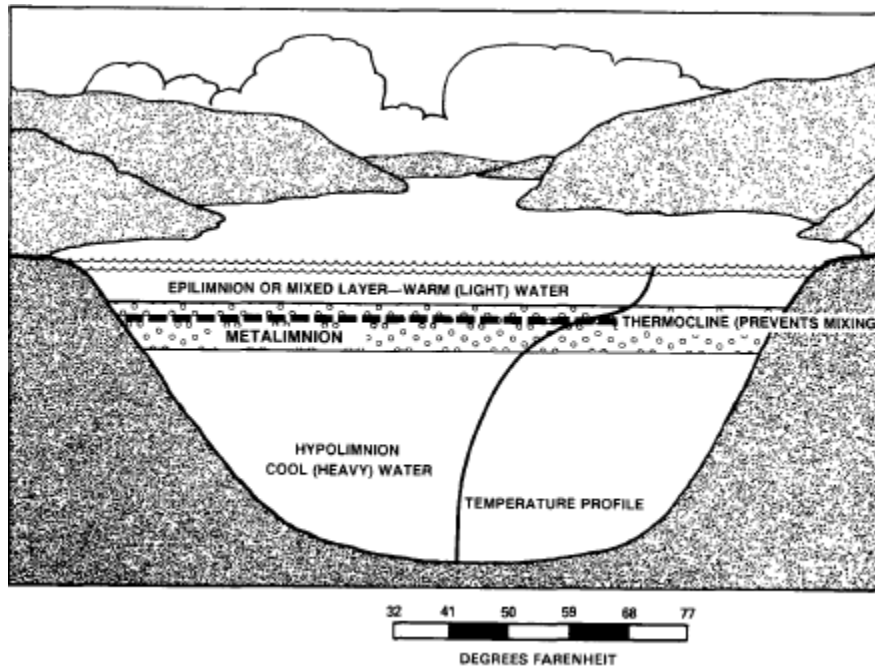
Figure A-2 Lake Stratification & Terminology

Epilimnion top layer of Lake, warmer and less dense – uniformly warm

Caused by changing temperature of epilimnion. Water is heaviest at 39.2°F. In spring, warming water is heavier and sinks and causes mixing with metalimnion and hypolimnion. In fall, cooling water is heavier and causes mixing with lower layers.

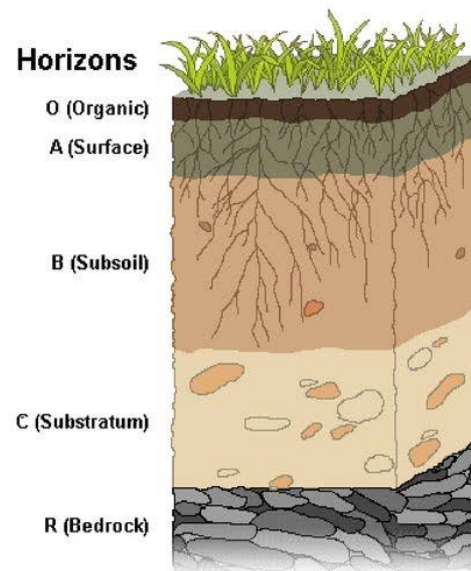
- Cross section of soil layers revealing all soil horizons
- O Horizon = organic material (humus)
- A Horizon = topsoil
- B Horizon = subsoil
- C Horizon = partially weathered parent material
- R Horizon = bedrock

- a: Highly decomposed organic matter (used only with O)
- e: Moderately decomposed organic matter (used only with O)
- g: Strong gley.
- i: Slightly decomposed organic matter (used only with O)
- p: Plow layer or other artificial disturbance
- w: Weak color or structure within B (used only with B)
